**US Army Corps
of Engineers**

**ARCHEOLOGICAL MONITORING OF THE
JACKSON AVENUE TO THALIA STREET
(PHASE 1) FLOODWALL PROJECT IN THE
CITY OF NEW ORLEANS , ORLEANS PARISH,
LOUISIANA**

FINAL REPORT

R. Christopher Goodwin and Associates, Inc.
5824 Plauche Street
New Orleans, Louisiana 70123

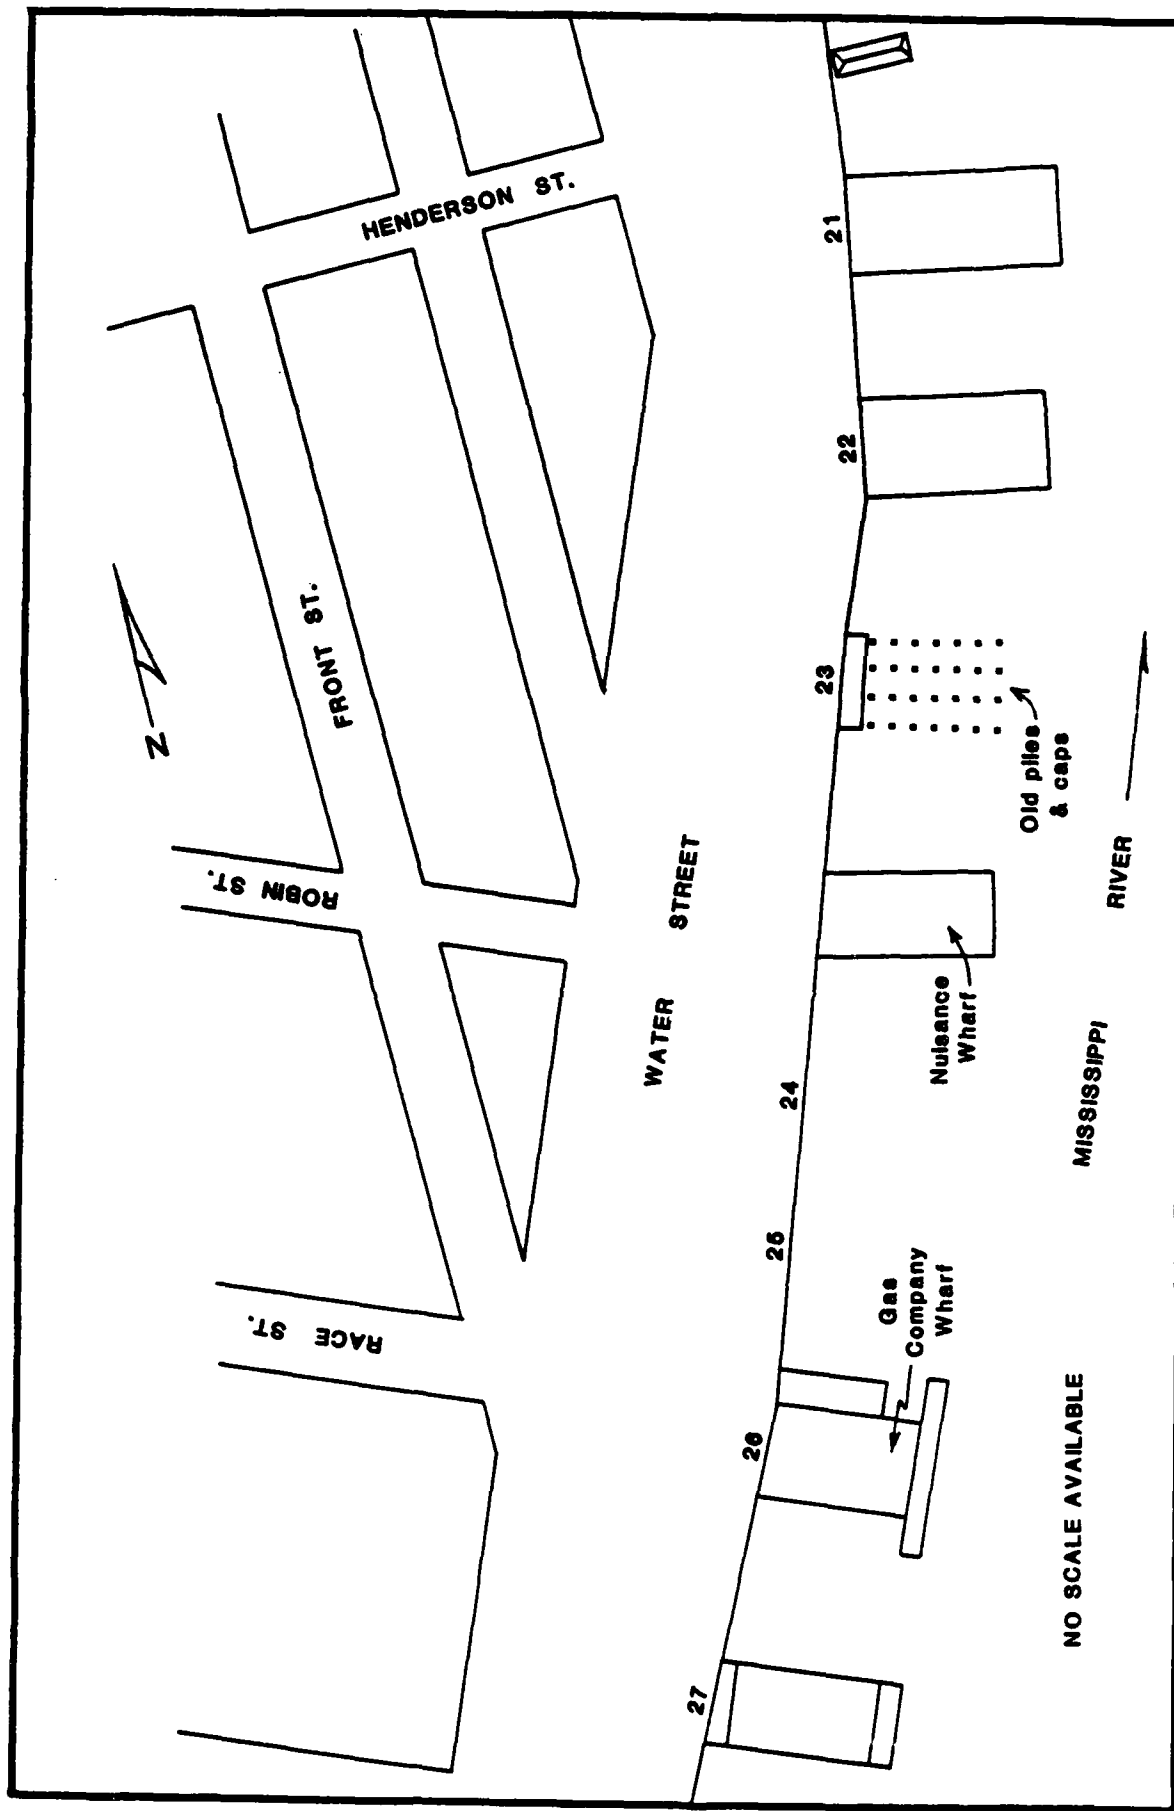
Figure 9. Redrawn Map from the Land Surveyors Sketch Book ca. 1877, showing the Robin Street Nuisance Wharf.

Specifications for the construction of a nuisance wharf at Robin Street are found in the Surveyor's ordinances dating from 1877. The details of the contract state:

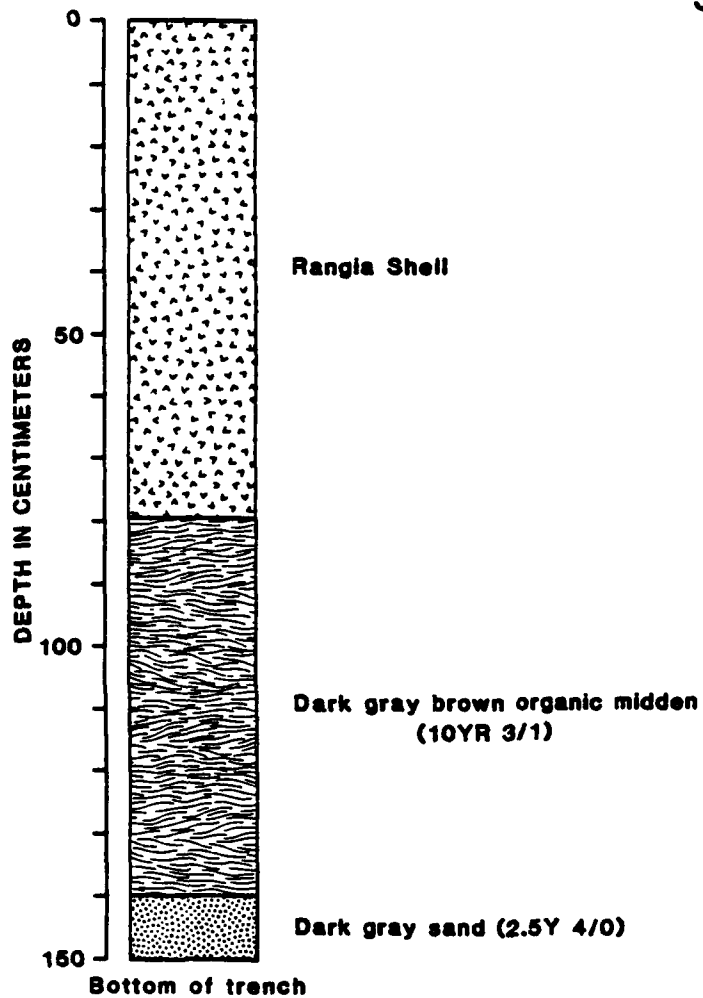
Figure 15. Profile of site 16 OR 116 at wall line station 47+50.

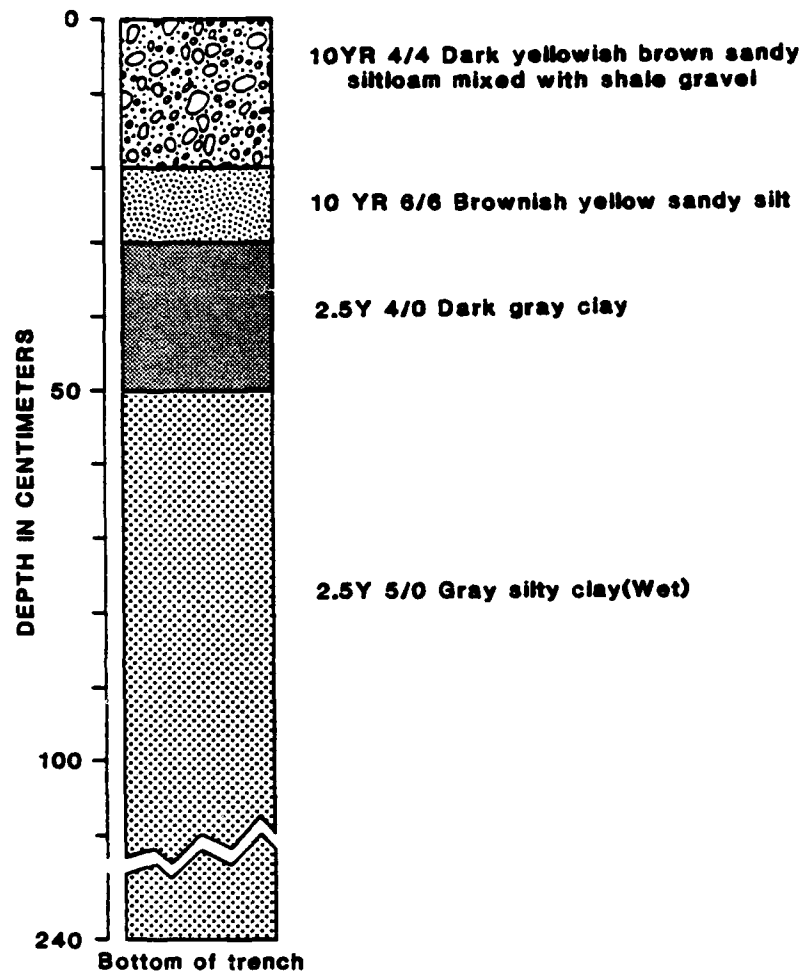
Figure 18. Reconstructed profile of site 16 OR 117..

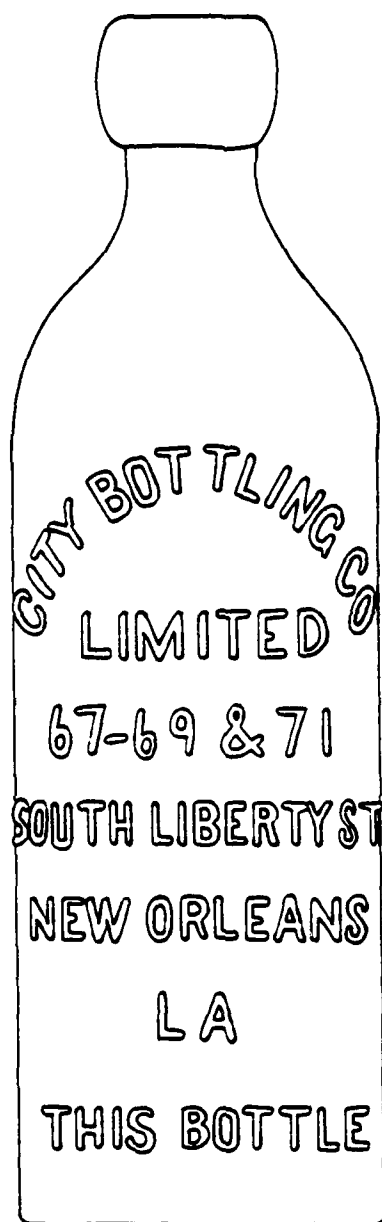
Figure 20. A locally produced mineral or soda water bottle recovered from 16 OR 117, dating 1896-1898. The complete statement embossed across the bottom read, "THIS BOTTLE NOT TO BE SOLD."

Two unidentified bottle sherds and one whole bottle were recovered from the St. James - Market Street trench. The whole bottle from 16 OR 117 is an aqua mineral or soda water container, embossed "City Bottling Co. Limited 67 & 71 South Liberty St. New Orleans LA. This bottle not to be sold" (Figure 20).

The one whole bottle recovered from the 16 OR 117 (Figure 20), bore the embossment "City Bottling Co., Limited, 67 & 71 South Liberty St., New Orleans LA, This bottle not to be sold." The specific contents of this bottle are unknown (probably mineral or soda water). This bottle,

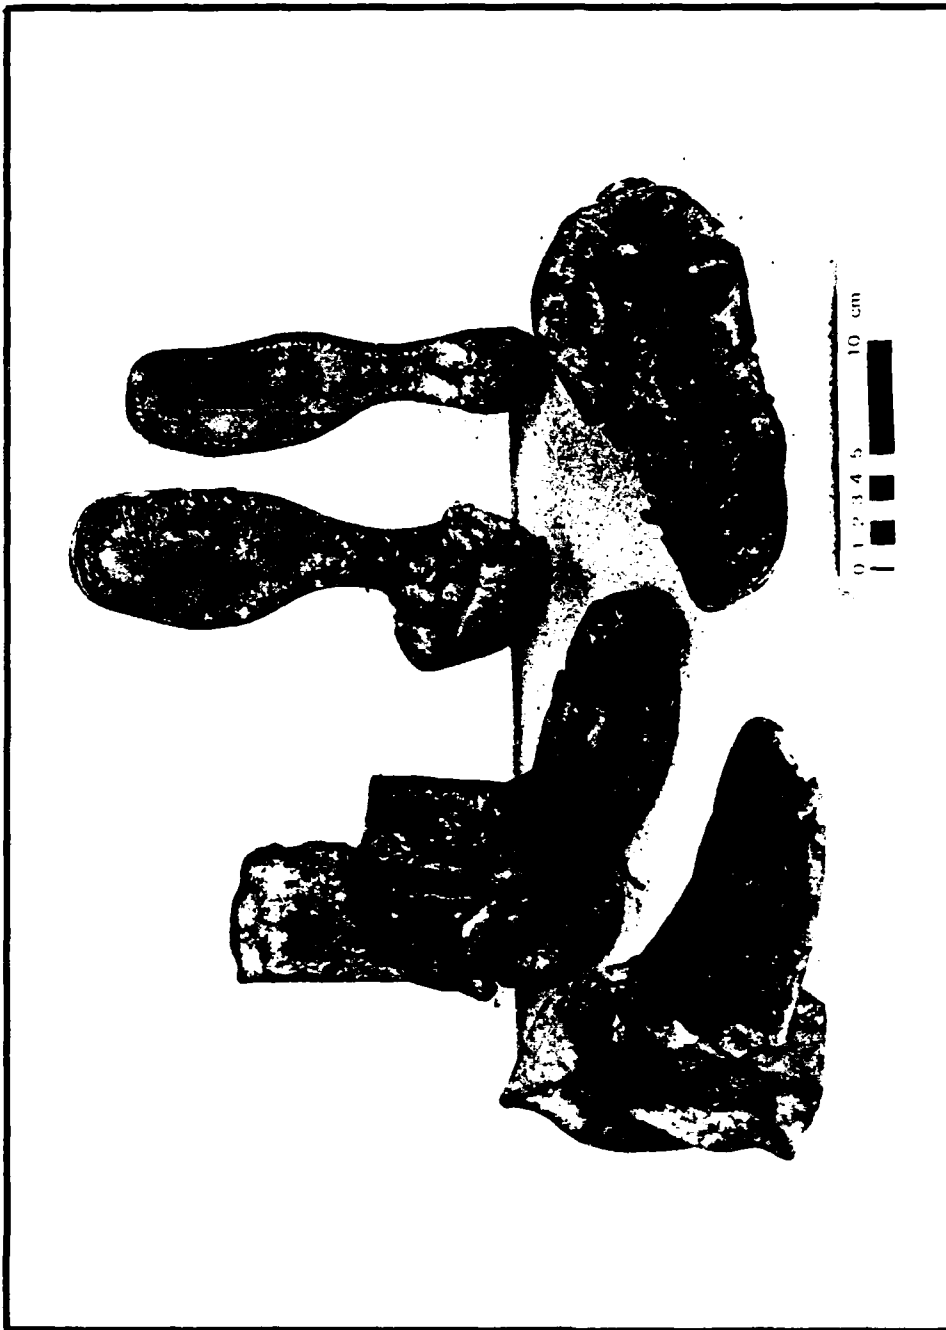
Figure 21. Selected shoe parts recovered at 16 OR 116.

outer soles (with wooden heels), and numerous upper shoe leather fragments. While all shoe soles demonstrated considerable wear, none displayed any evidence of repair beyond the possible reattachment of a heel. The shoes displayed the technology of manual manufacture (Figure 21). The two recognized nineteenth century technological characteristics identified among this collection were French rivets and use of the Blake Sewer (see below). The French rivet is a small-headed tack, usually constructed of steel or brass, which was used to attach the soles of the shoes to the leather uppers (Wright 1922:228). These rivets were used in the production of three of the whole or partial shoes in this collection. The Blake Sewer sewed through the inner and outer sole, while catching the edges of the upper leather (Wright 1922:227). However, the toe of the shoe still had to be finished by hand. One boot displayed evidence of this manufacturing technique.
